Project **110-112 N. Fourth St.**

Location Oregon, Illinois

Title	Facade recommendations
-------	------------------------

Date April, 2009

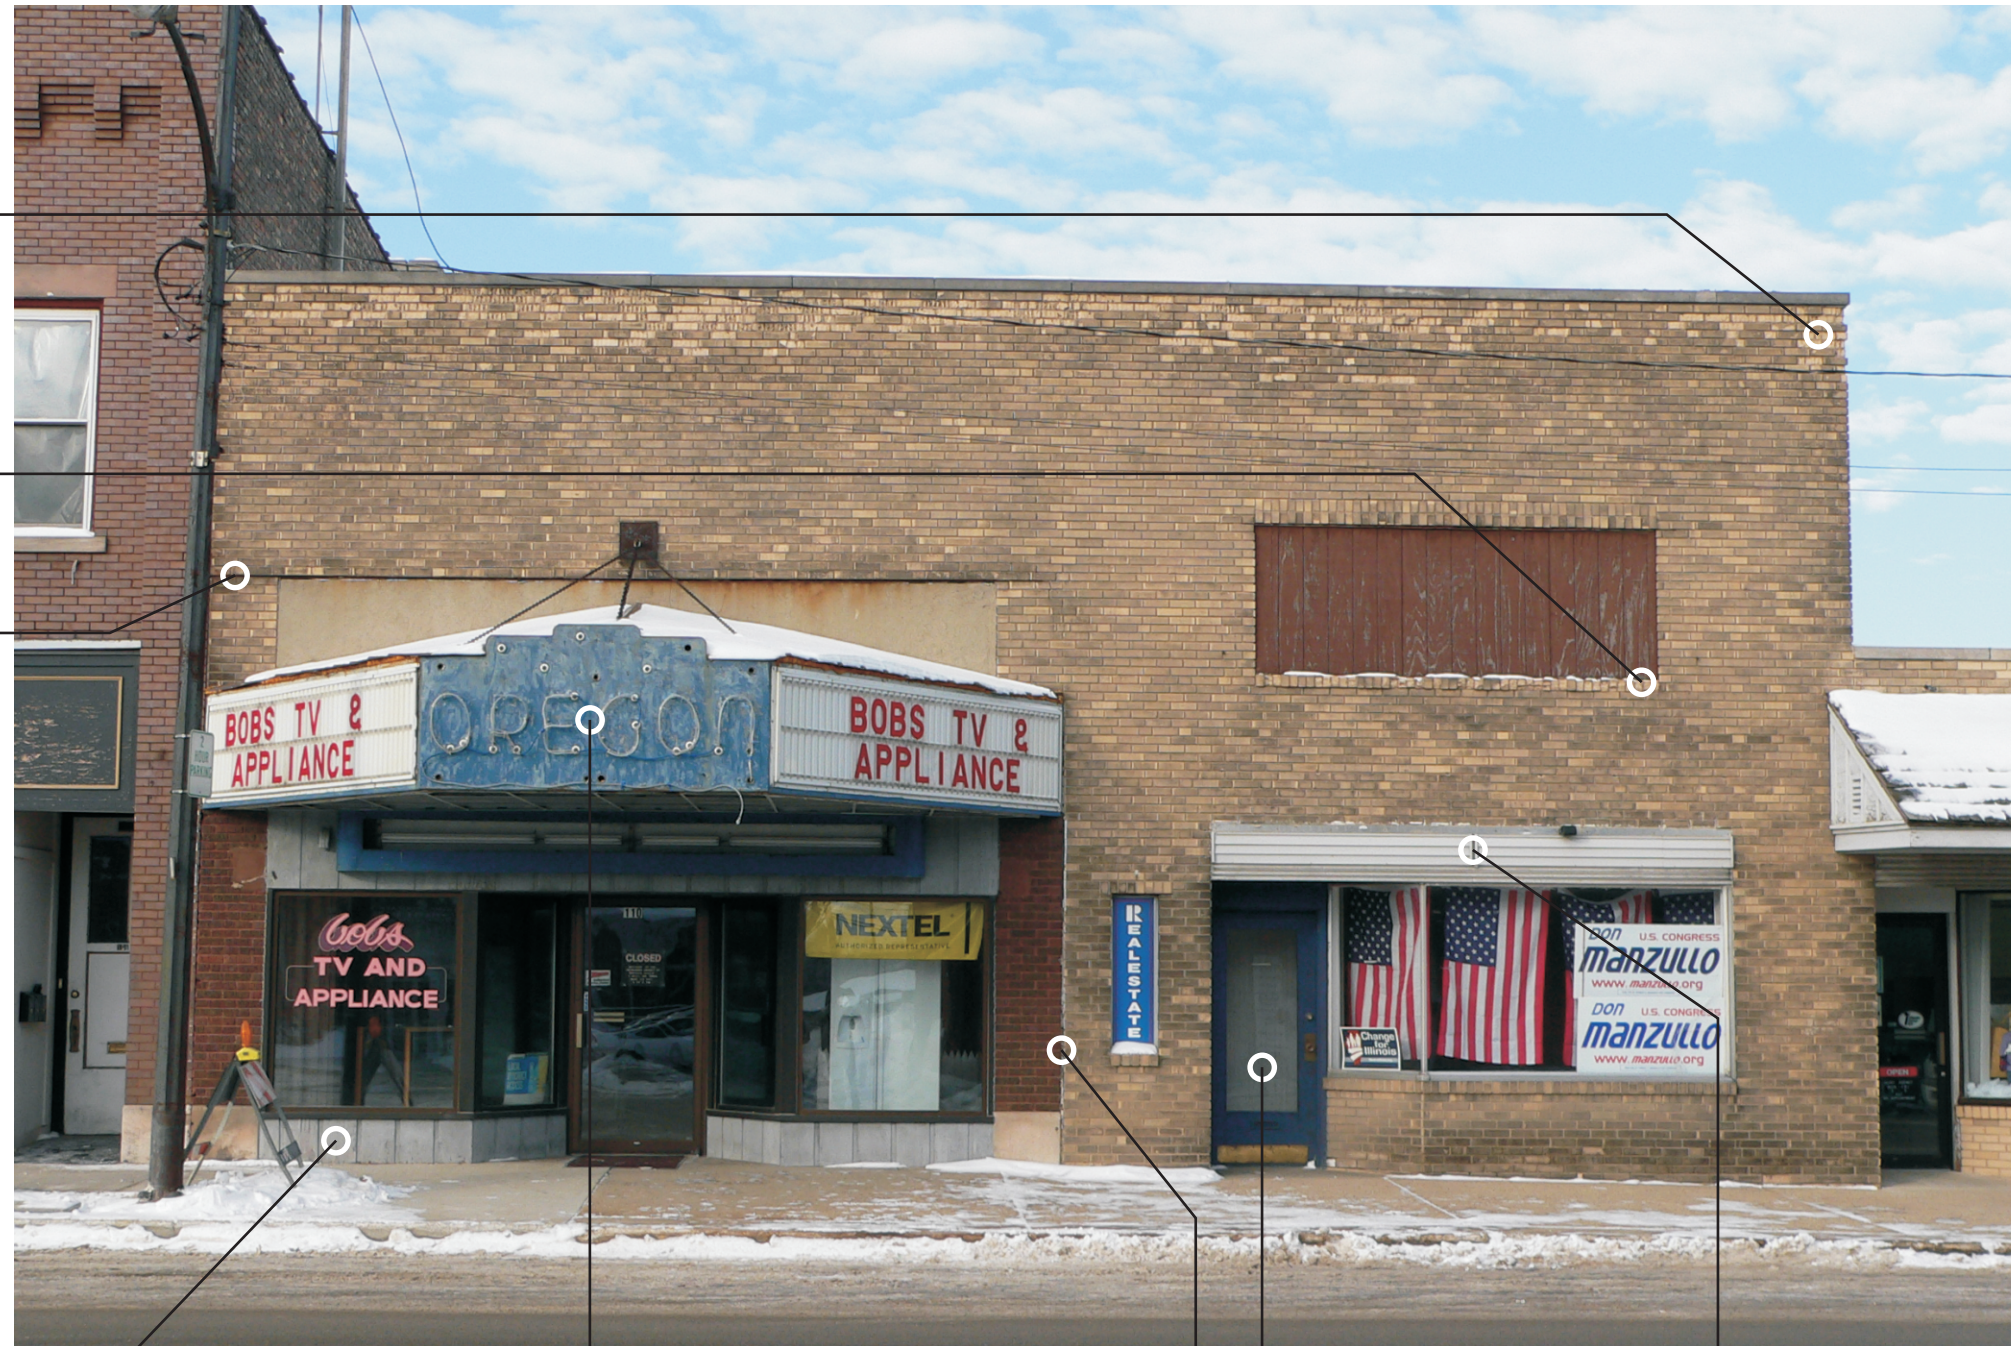
Theater marquee needs to be restored. Use historic photos for guidance. There have been various repairs performed over the years, some of which have to be undone. The marquee anchor should be inspected for its structural capacity.

It is unlikely that historic fabric remains under the vertical wood siding, however further investigation is recommended. At the very least, the wood should be repaired and painted. If no historic fabric remains, bulkheads may be recreated based on historic photos of the theater.

Retain historic wood door
and aluminum storefront.

Remove old caulk and install a proper expansion joint between the original storefront and the 1940s alteration. Repeat procedure on the south edge, where the building meets the adjacent structure.

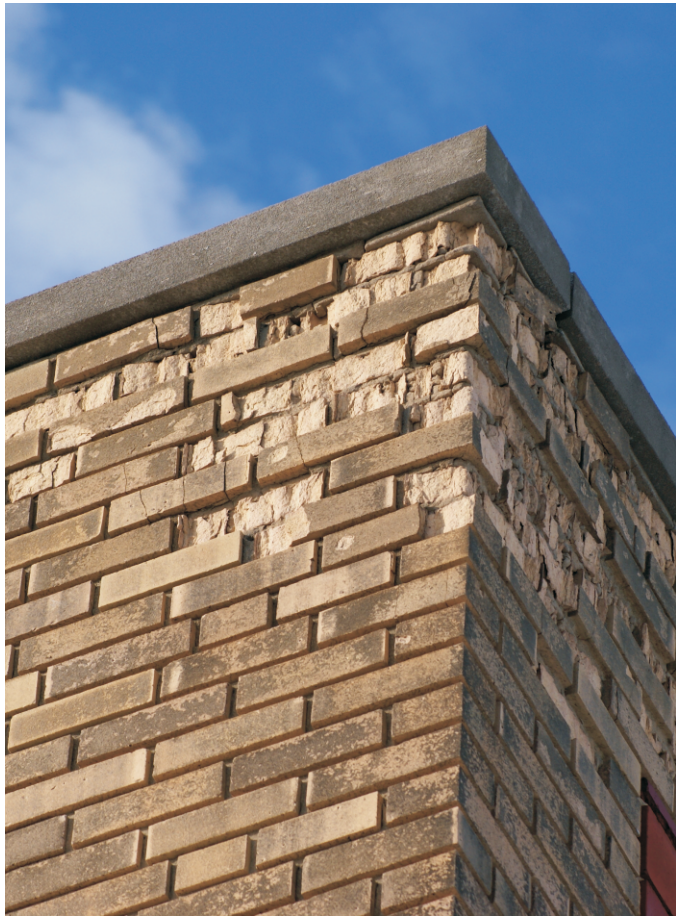
● *Detail D1*

North top corner of facade

Top courses of the parapet are consistently spalling across the entire front and around the corner. While the cause is not obvious, it is likely water penetrating the wall through improper or damaged roof and parapet flashing. Once the source of water is eliminated the brick should be repaired. Since matching the brick is going to be difficult, the best solution would be to carefully remove the existing parapet and rebuild it utilizing salvaged brick while incorporating decorative courses of new brick. Aside from aesthetics, if not addressed the damaged bricks will continue to deteriorate since their hard outer core has been damaged.

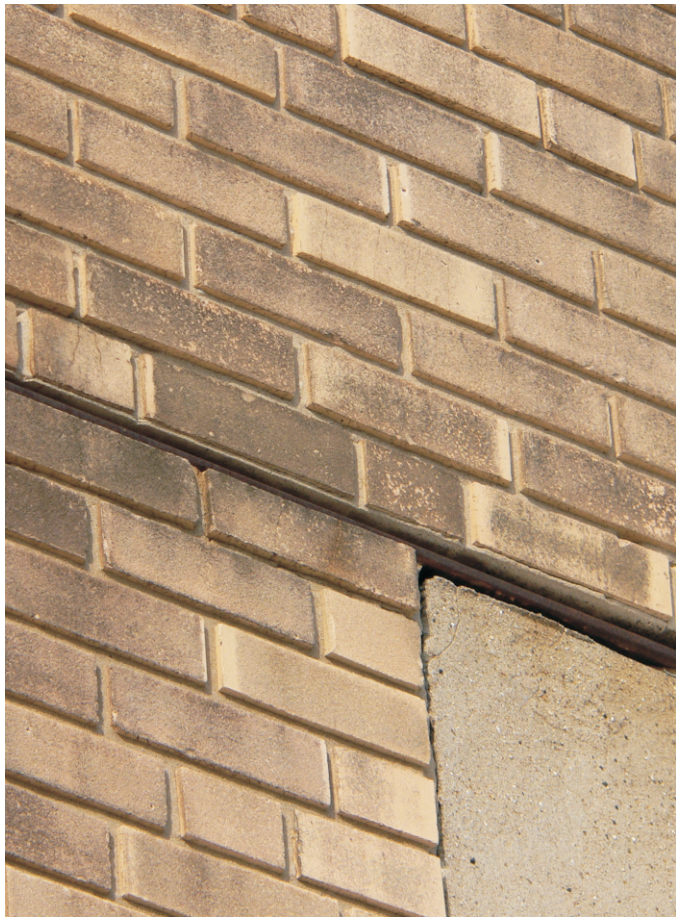
● *Detail D2*

Near north edge of facade, upper story window

Damaged window sill should be removed and rebuilt either of new compatible brick or with concrete or limestone. Since there are no other window sills, a visual mismatch is less of a concern. Window should be uncovered and the historic window appropriately repaired or if missing or beyond repair, a new historically appropriate window installed in its place.

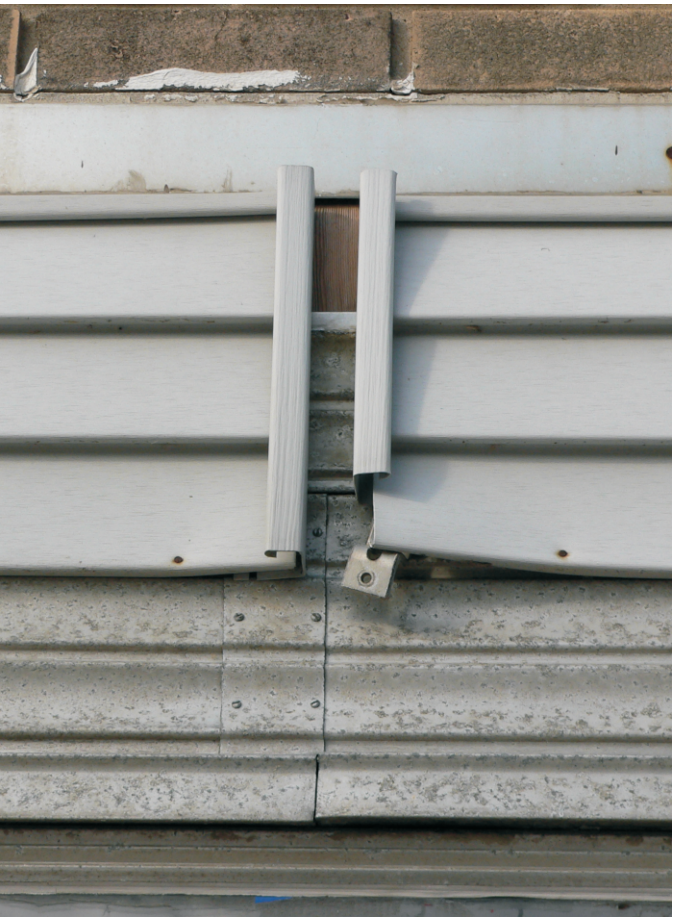
● *Detail D4*

North storefront, above the front display window

Remove non-historic aluminum trim to reveal historic aluminum moulding. Missing pieces should be reinstalled and can be found through a salvage yard.
