#### **OREGON Theater Project Summary**

### **BUILDING ASSESSMENT REPORT**

### **OREGON THEATER BUILDING**

#### **Oregon Theatre Structural Inspection Report**

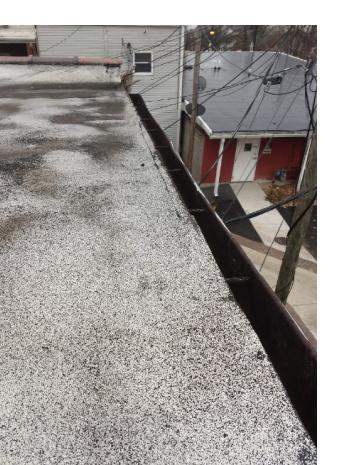
#### BUR - Edge Detail (Emergency)

Quantity: 50 LF **Deficiency:** Roof membrane has separated from metal edge. **Corrective Action:** We will remove the loose membrane, secure metal edge joint, clean and prime metal and install new material that extends 3" onto the roof to ensure a watertight condition.

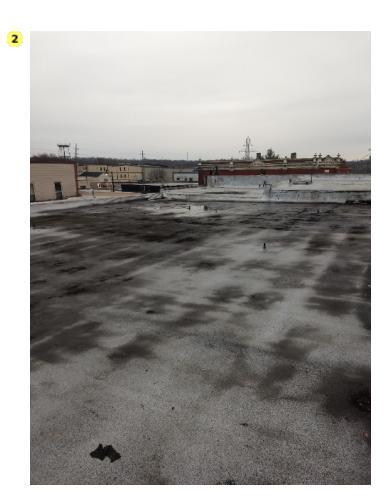
### General - Ponding (Remedial)

Quantity: 2000 EA **Deficiency:**

A ponding water condition is due to inadequate flow of water to drains or the underlying insulation has collapsed due to age or weight and created a low lying area that holds water. **Corrective Action:**

A ponding water condition is best corrected during a re-roof project.

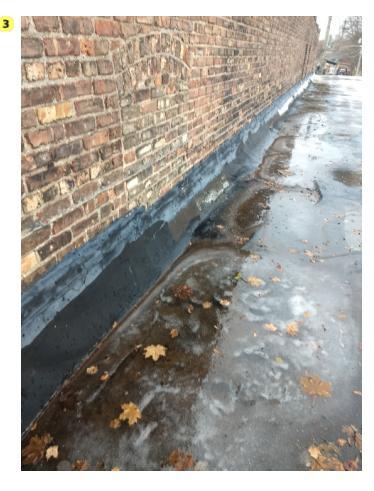
Ballasted EPDM - Caulk Failure (Emergency) Quantity: 75 LF Deficiency: The caulking/ sealant is failing and allowing water in. Corrective Action: Remove old caulk prime area and replace with new sealant.

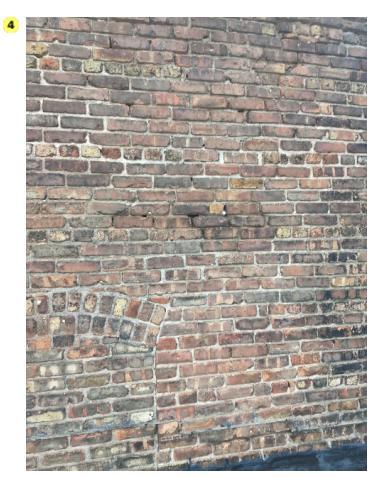
General - Neighbors Masonry (Emergency) Quantity: 500 LF Deficiency: Masonry in bad condition Spalling bricks and open mortar courses. Corrective Action: Other

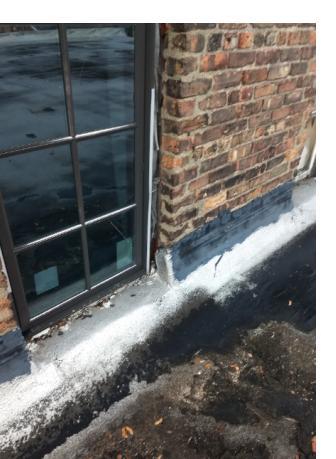
BUR - Neighbors Windows (Remedial) Quantity: 6 LF Deficiency: Roof is terminated into neighbors windows Corrective Action: Other

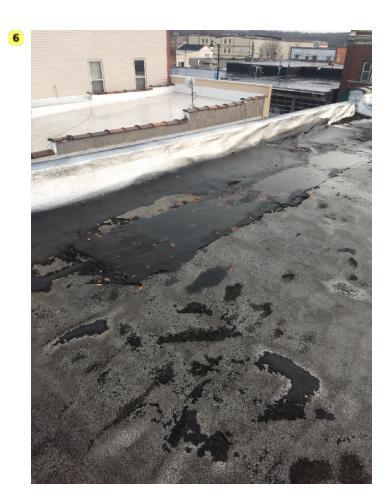
BUR - Previous Repair Failure (Emergency) Quantity: 3 EA Deficiency: Existing repair failing due to age. Corrective Action: We will remove existing repair, clean and prime area and install a new patch to ensure a watertight condition.

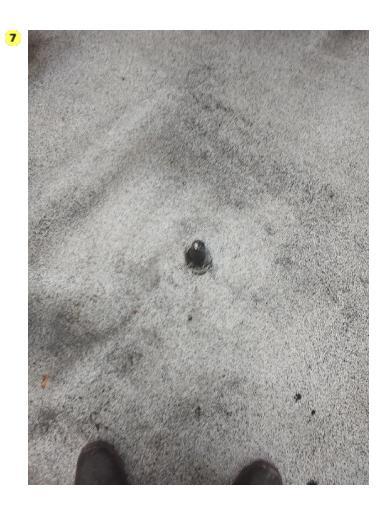
BUR - Failing Penetration (Remedial) Quantity: 6 EA Deficiency: Due to overall age, weathering and UV the penetration has failed. Corrective Action: The penetration should be repaired per industry standards to ensure a watertight seal.

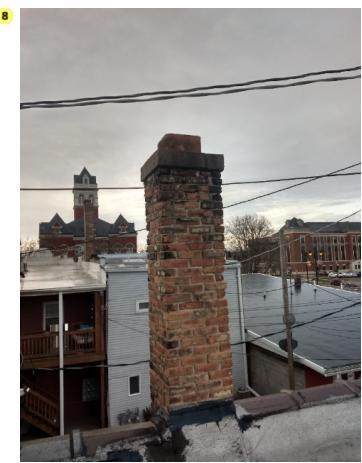
- Building masonry is in poor condition and should be addressed as a top priority. The existing masonry chimney at the SW corner of the building is leaning and is a considerable concern. It is recommended that the existing chimney be removed and rebuilt or replaced if still in use. The face masonry around the entire building perimeter is in poor condition and with numerous spalled/missing brick and poor mortar joints. It is recommended that the damaged face brick be removed and replaced, and joints repointed at all exterior faces of the building.

BUR - Masonry (Remedial) Quantity: 1 EA Deficiency: Chimney is leaning to one side. Corrective Action: Other

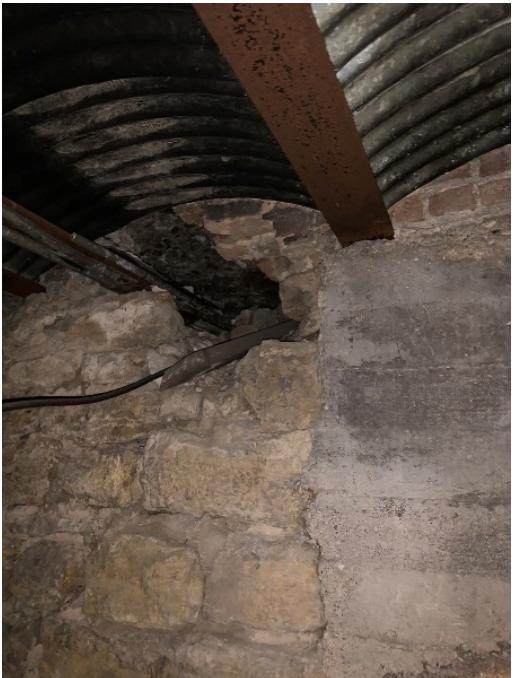
Concrete/Stone Wall Interface

The north foundation wall visible in the basement level appears to be near the middle of the main floor area. As noted previously, the foundation walls are a combination of concrete and stone. The stone portion of the wall was noted in a center portion of the north wall with cast in place (CIP) walls butting up to it on the east and west sides, which extended to the east and west walls. An apparent pipe chase was knocked out of the north end of the stone wall, exposing a portion of the area under the north half of the main area. It was unclear if that area has or had a crawl space or was a slab on grade. Concrete floor is visible through the opening, however steel beams and corrugated SIP forms as observed in the basement were not obvious. A timber beam, supported at each end by the foundation walls and in the center by a brick column, was present at the transition from the low end of the sloped floor and the level floor in the stage area.

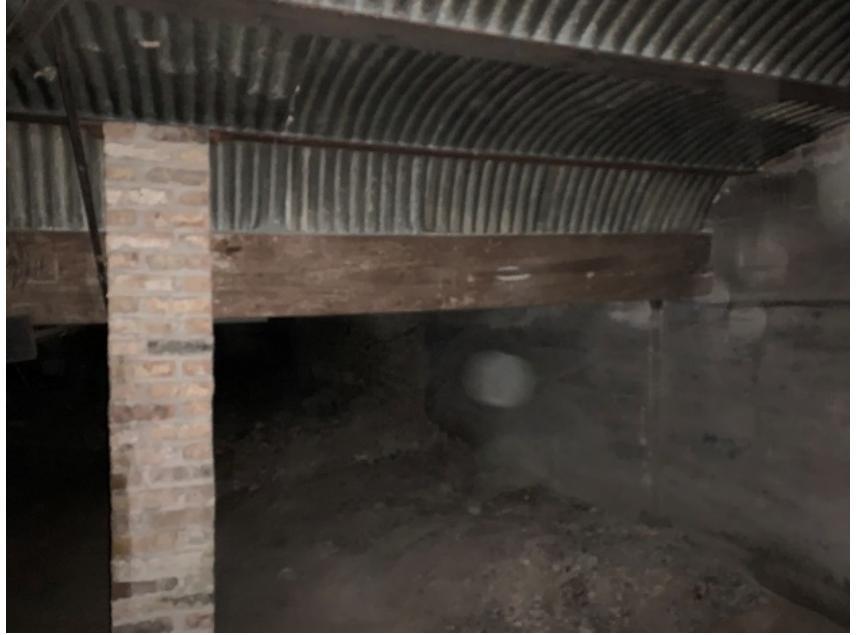
Timber beam at floor transition

There were no signs of long term or extended moisture infiltration in any of the visible/accessible portions of the foundation walls. The timber beam and masonry column

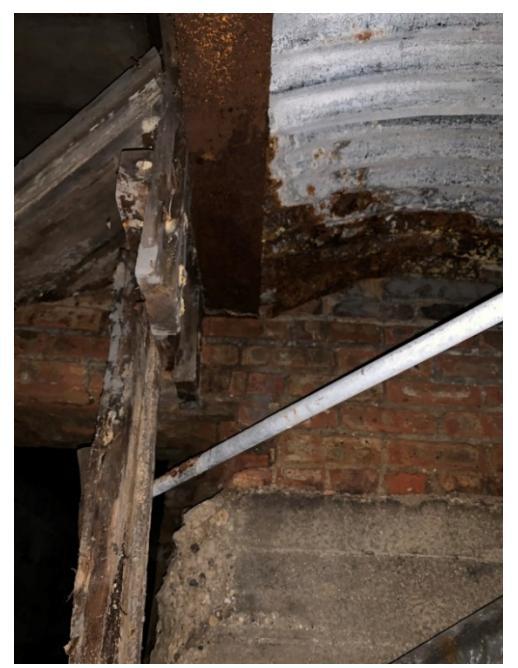
appear to be in good condition. The steel beams and SIP forms are in good condition, except in west end under the stage, where they were in fair condition. The beams do not appear to have been painted and have rust scale which is not a significant concern. The beam and form ends are beginning to experience some section loss and flaking. The SIP forms are not an integral part of the structure, however cleaning and painting the beams to arrest deterioration should be considered.

Deterioration at beams and SIP forms in stage area
