#### **OREGON Theater Project Summary**

### **BUILDING ASSESSMENT REPORT**

### **OREGON THEATER BUILDING**

#### **Oregon Theatre Structural Inspection Report**

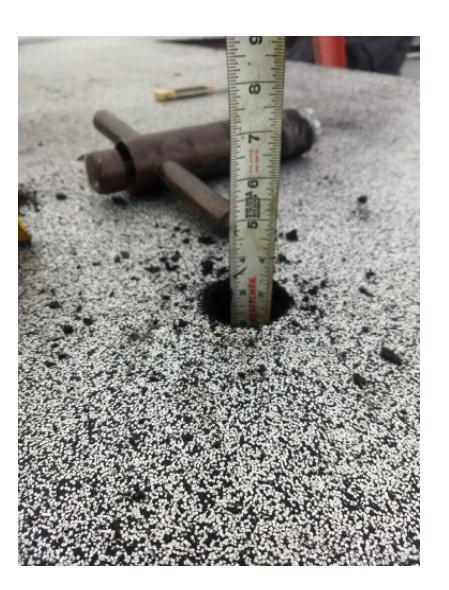
Core Cut Wood deck 1/2 inch perlite Coal tar and gravel 1' Isocyanurate insulation Asphalt and gravel SBS granulated bur roof

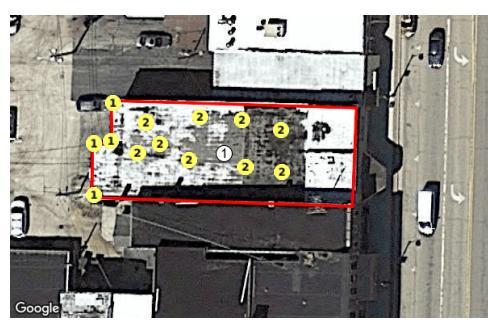
#### BUR - Edge Detail (Emergency)

Quantity: 50 LF **Deficiency:** Roof membrane has separated from metal edge. **Corrective Action:** We will remove the loose membrane, secure metal edge joint, clean and prime metal and install new material that extends 3" onto the roof to ensure a watertight condition.

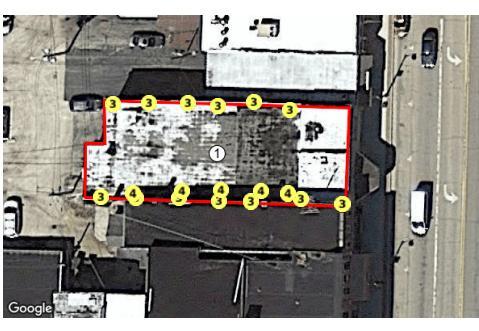
Ballasted EPDM - Caulk Failure (Emergency) Quantity: 75 LF Deficiency: The caulking/ sealant is failing and allowing water in. Corrective Action: Remove old caulk prime area and replace with new sealant.

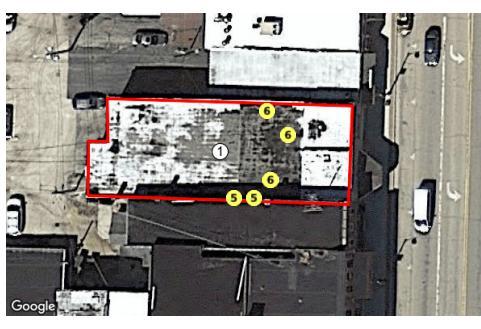
BUR - Neighbors Windows (Remedial) Quantity: 6 LF Deficiency: Roof is terminated into neighbors windows Corrective Action: Other

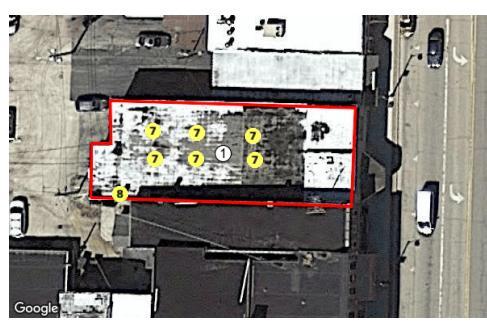
BUR - Failing Penetration (Remedial) Quantity: 6 EA Deficiency: Due to overall age, weathering and UV the penetration has failed. Corrective Action: The penetration should be repaired per industry standards to ensure a watertight seal.

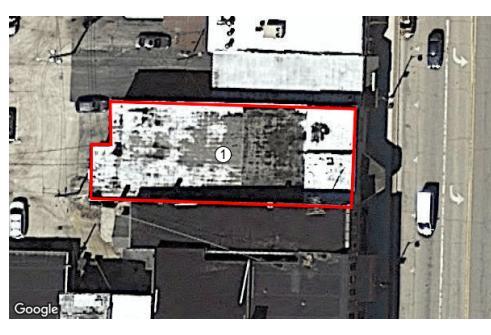
This roof is past its service life. There are 3 roofs on this structure which is not allowed by code. This roof should be torn down to wood deck and replaced with new. Masonry on neighbors wall is in bad shape. Chimney on theater is leaning and poses a safety hazard. Gutters and down spouts are rusted thru in several spots and should be replaced as well.
